Gear Crack Detection Using Tooth Analysis

Harry J. Decker U.S. Army Research Laboratory, Glenn Research Center, Cleveland, Ohio

Prepared for the 56th Meeting sponsored by the Society for Machinery Failure Prevention Technology Virginia Beach, Virginia, April 15–19, 2002

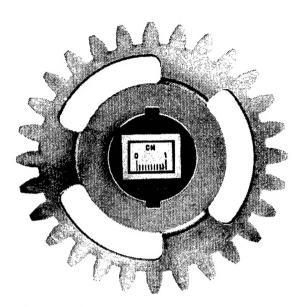
Figure 3. Representative gear for crack tests

A notch was machined in the root area of the gear to provide a concentrated flaw from which a crack could initiate. This location was chosen since this is the point of highest tensile stress on the gear tooth surface. The higher stress provides the best opportunity for crack propagation.

The notch traversed the entire face width of the gear and was created using electrical discharge machining (EDM); this process was chosen for its ability to control the size of the notch. The size of the notch is controlled by both the shape and electric current of the electrode and is typically 0.254 mm (0.010 inch) deep.

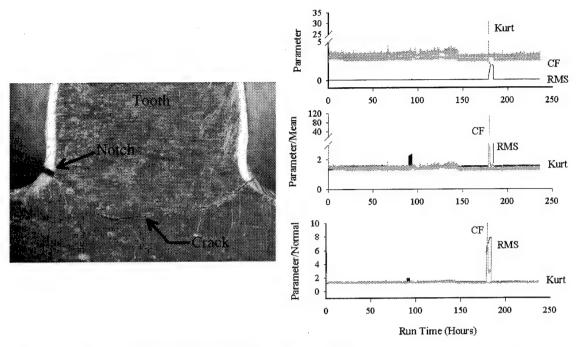
<u>Test 1:</u> This test, run at 125-155 Nm (92-114 ft-lb) torque and 2500 rpm produced a tooth fracture (Figure 4) after almost 237 hours. The original notch is readily visible in the fillet on the left side of the gear tooth. The crack initiated at the edge of the notch and progressed to the fillet on the right.

Figure 4. Gear tooth fracture after test 1 Figure 5. Test 1, case accelerometer analysis

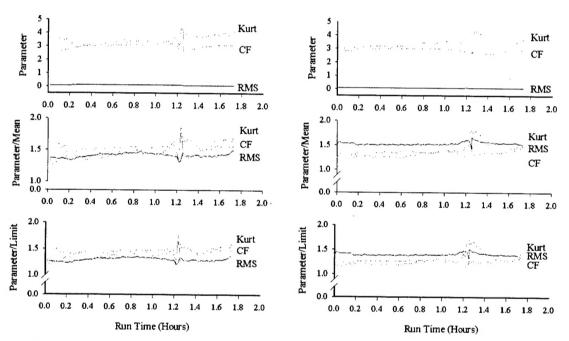
Test 2: Test 2 was conducted at 5000 rpm and 155 Nm (114 ft-lb) torque. This test ended at 1.7 hours with a fracture through the rim (Figure 6), which may have been caused by operation near a gear resonance condition. At 1.25 hours, high vibration levels caused an automatic test shutdown. The gear was examined and a mark taken to be dirt or fuzz was noticed. This may have actually been the crack that eventually propagated through the rim.

Figure 6. Gear rim fracture after test 2
